Integrity Pro Inspections, LLC

Home Inspection Report

**Any Home America
Albany, GA 31705**

Inspected on Sat, Dec 29 2018 at 9:30 AM

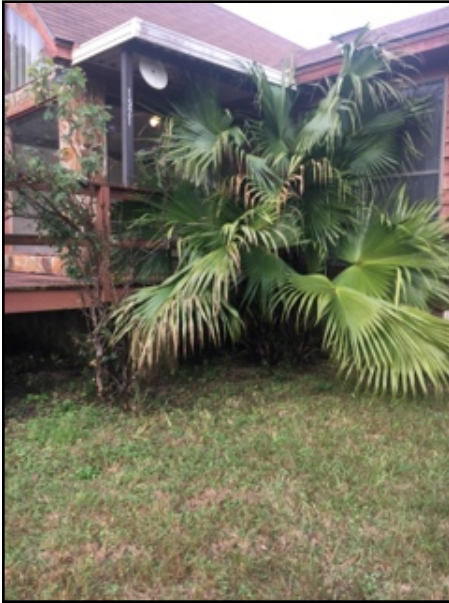
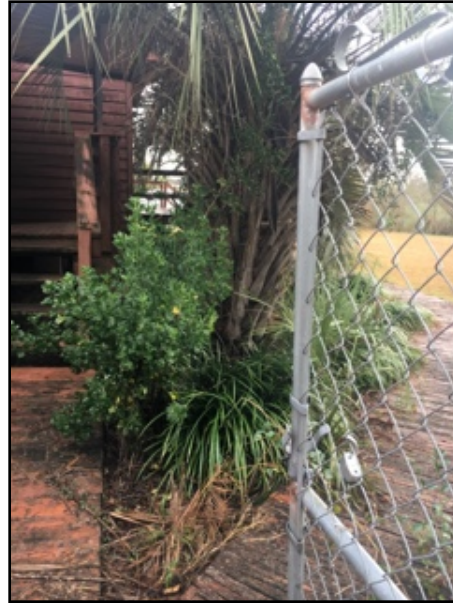
Plants growing against Home can cause rot, moisture, and termites. These should be trimmed marginal.

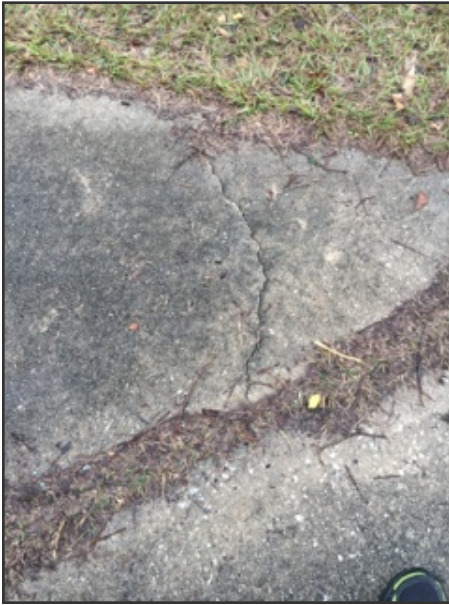
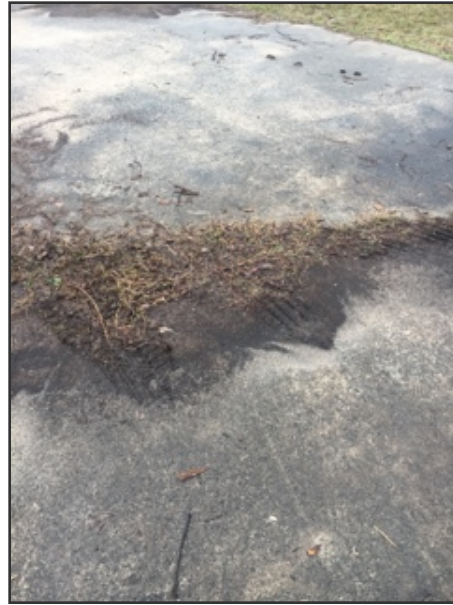
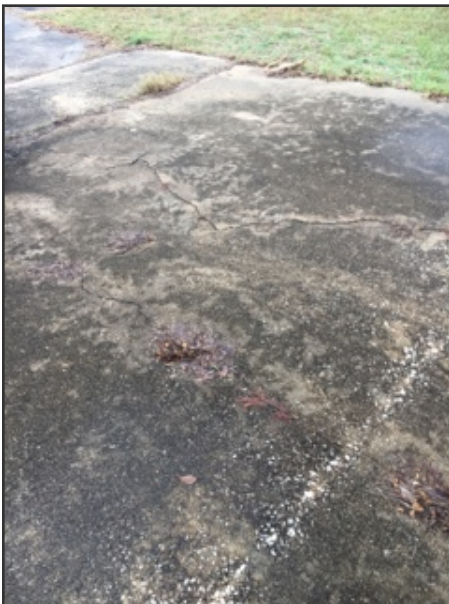
Comment 3:
Minor cracking from settlement- marginal.

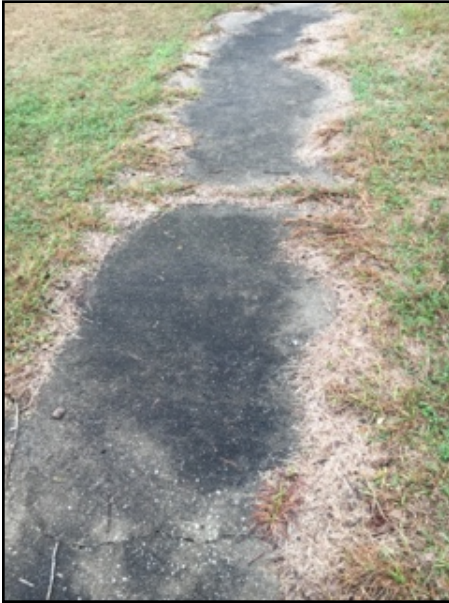
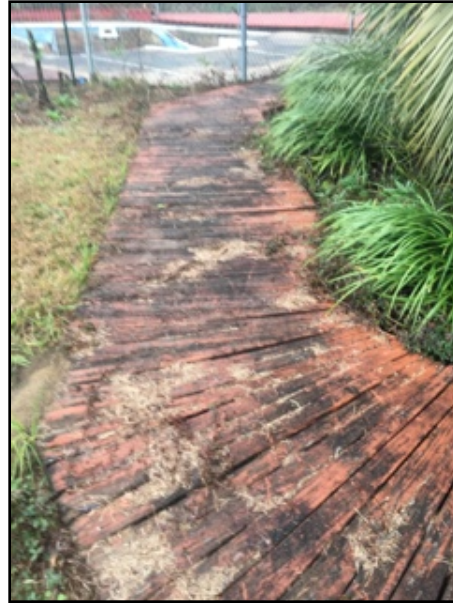
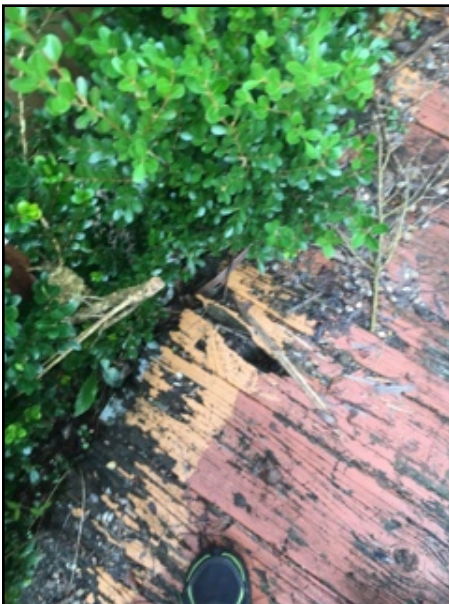
Wooden walk way near pool has a lot of wood rot. Recommend full replacement

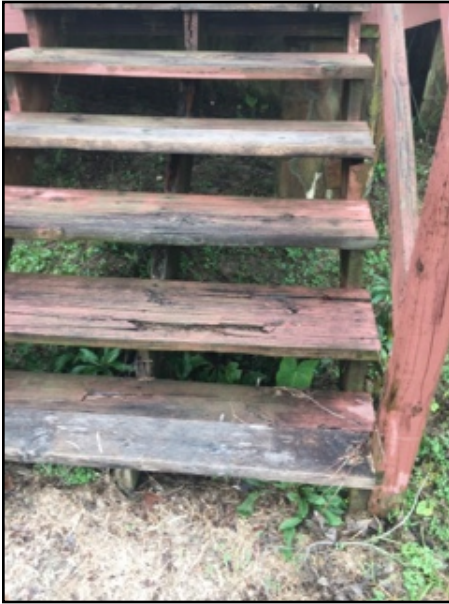
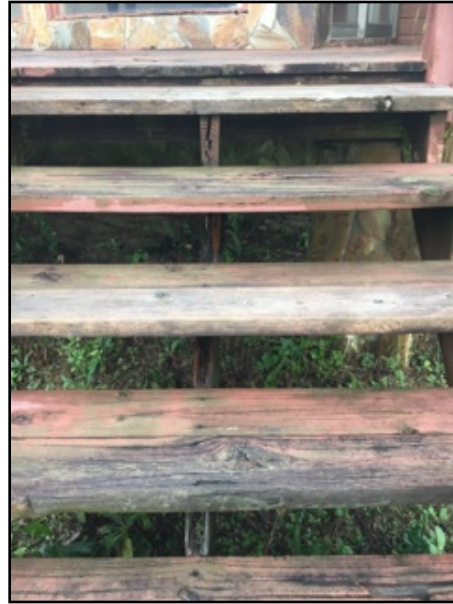
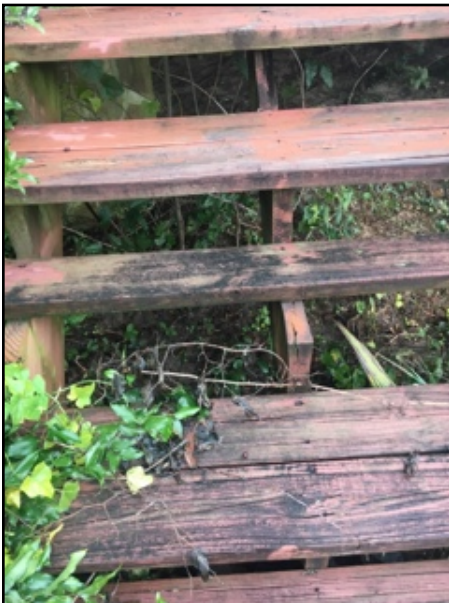
Wood steps old and rotten. recommend full replacement by a qualified contractor

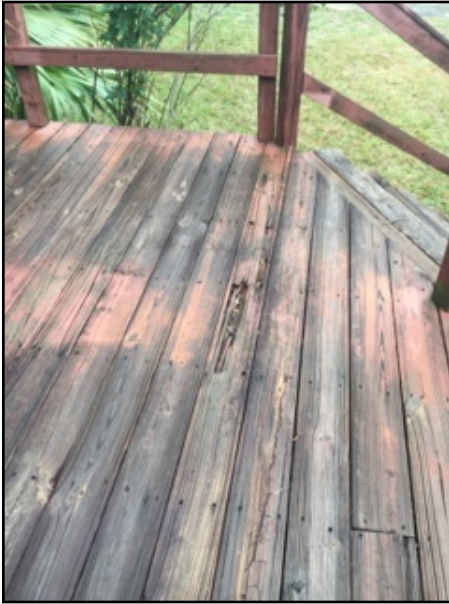
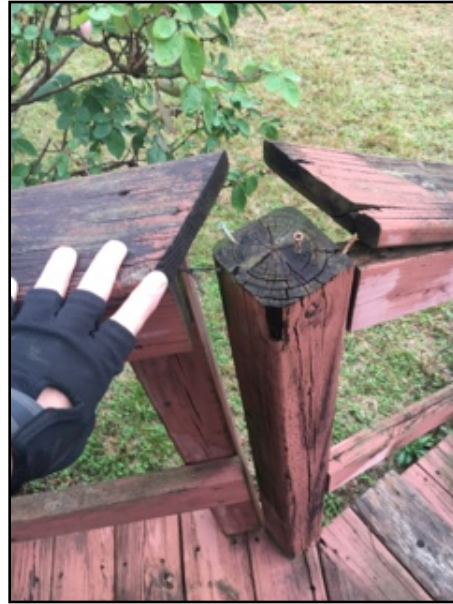
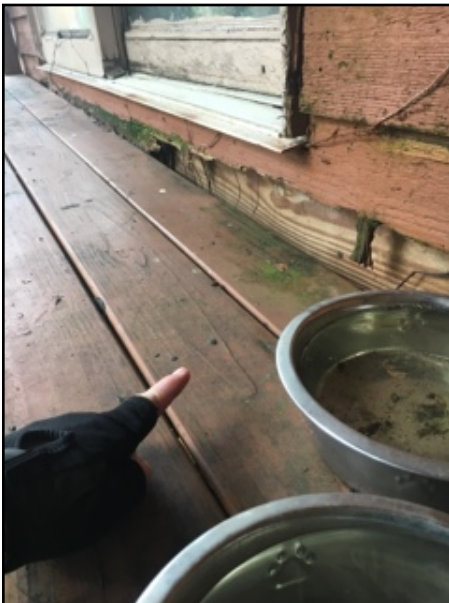
Deck from master bedroom ledger board completely detached from home.
All deck boards have rot and cracking
Handrails Rotted in need of replacement
Recommend further evaluation by a qualified contractor

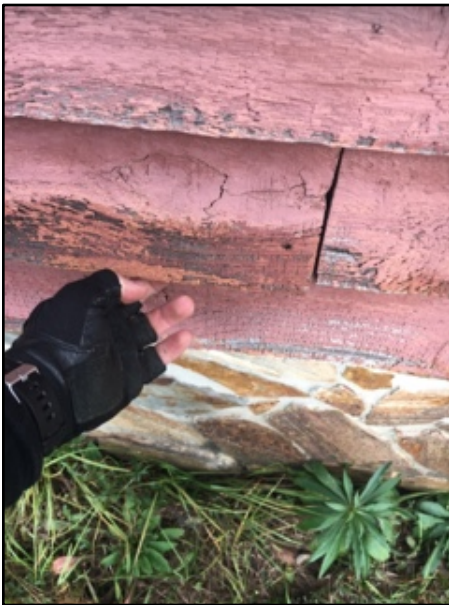
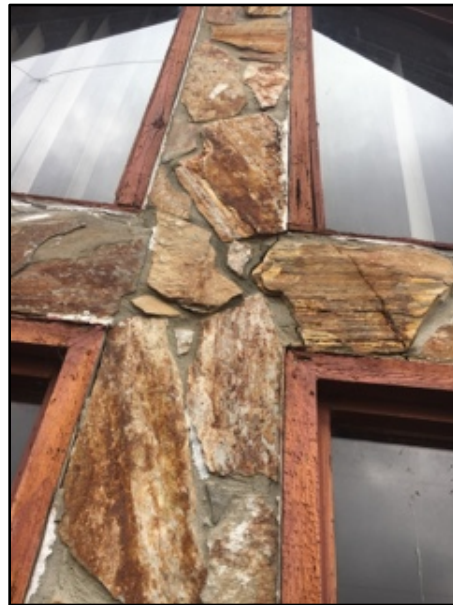
Some of the wood siding rotted and cracked. Some segments will require replacement and sealing. Further evaluation recommended by a qualified contractor.

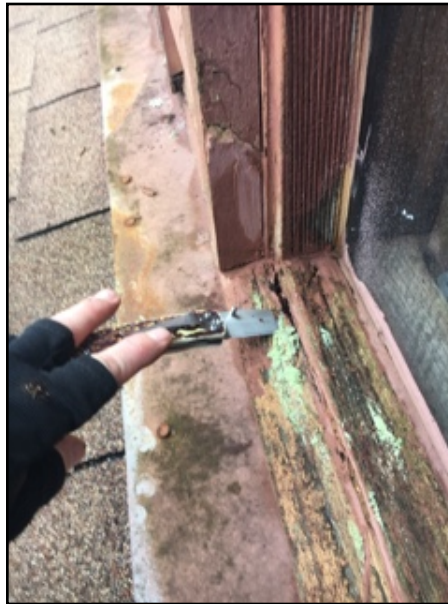
Sky light windows. Wood frame rotted from water entry. Recommend repair by a qualified contractor

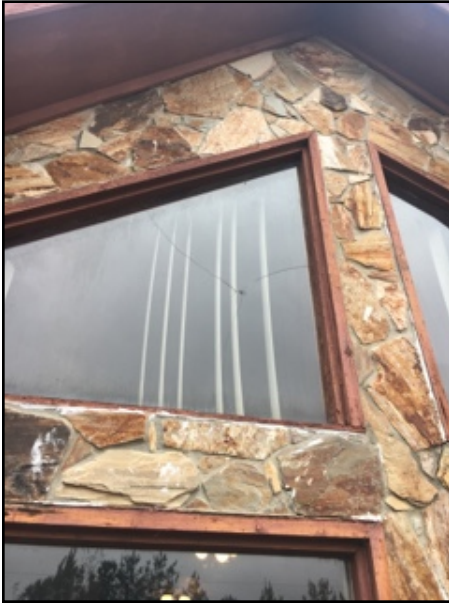
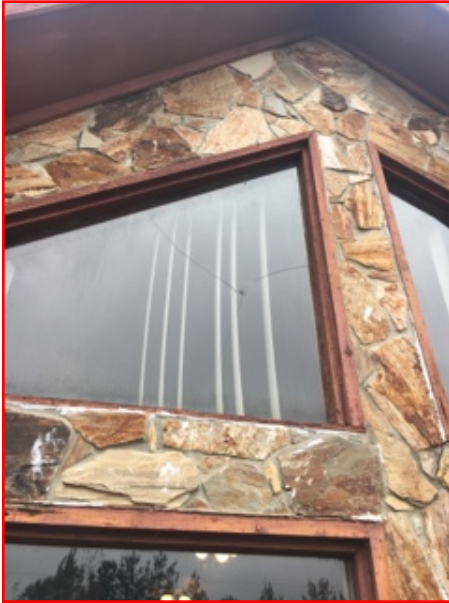
Figure 10-1

Comment 10:
Sun room window broken will require replacement .

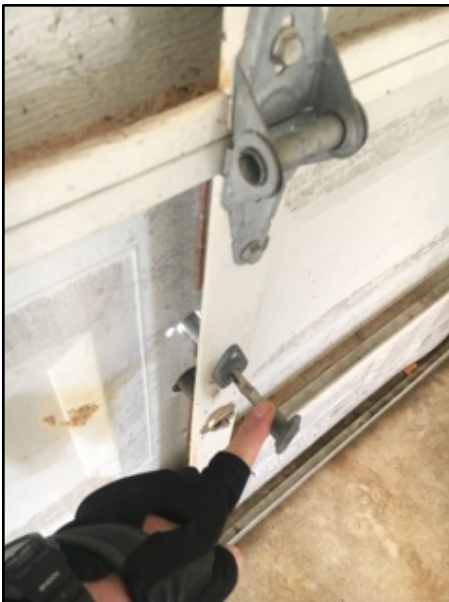
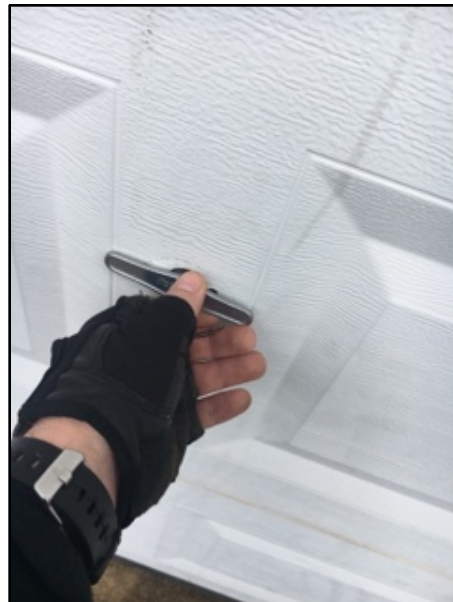
Garage door on left. Latch broken. Further evaluation recommended by a qualified contractor

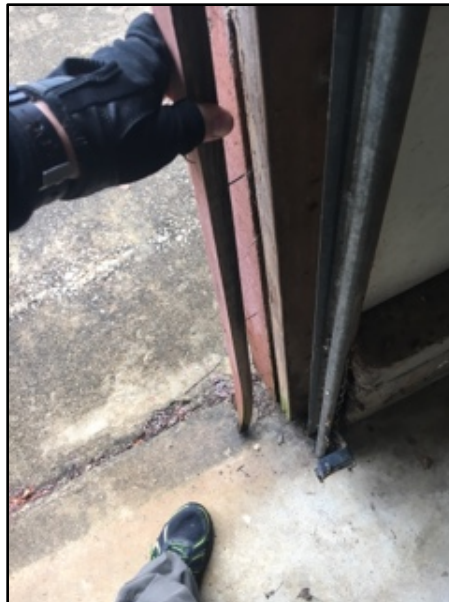
Cosmetic work and maintenance will be required. Further evaluation by a qualified contractor

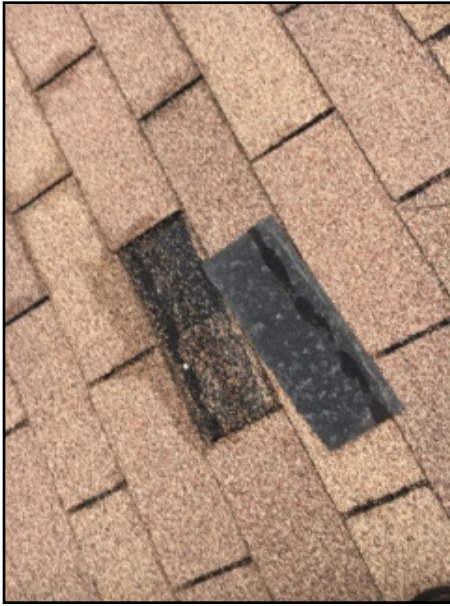
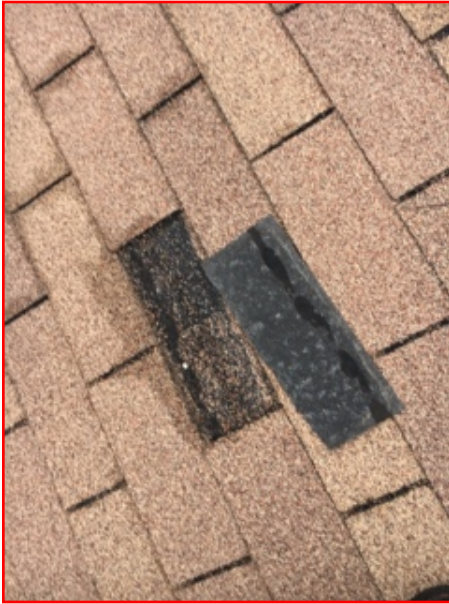
Figure 15-1

Shingles are broken in some areas. this could be due to recent hurricane (hurricane Michael)Will require repair or replacement by a qualified contractor. Recommend full replacement and repair.

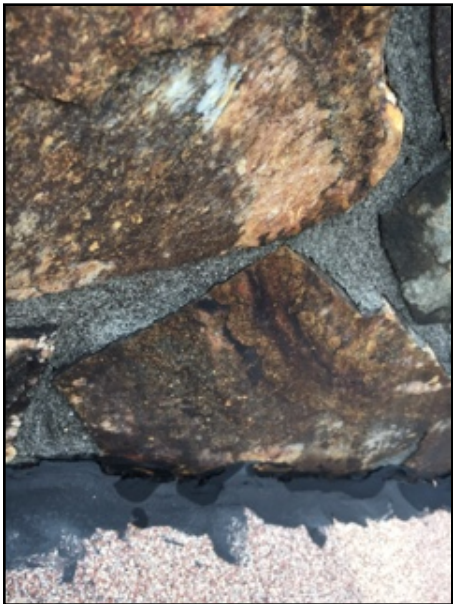
Comment 16:
Sealant between chimney and roof cracking. Recommend repair by a qualified roofer to prevent water intrusion and further damage.

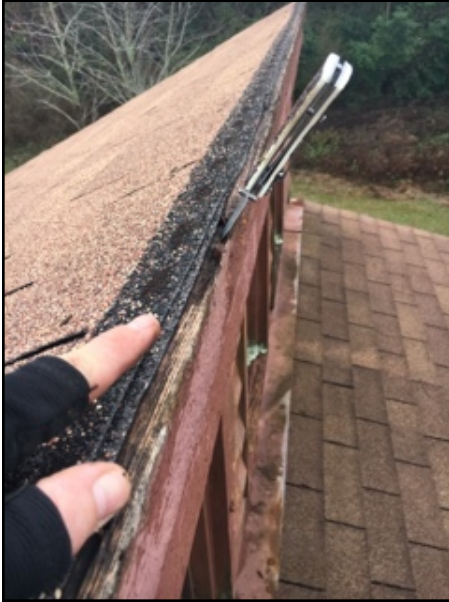
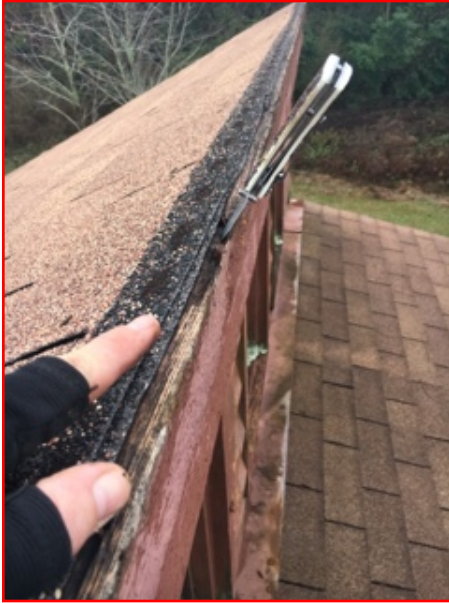
Figure 17-1

Wood rot along roof above skylight windows. Water entry point recommendation repair

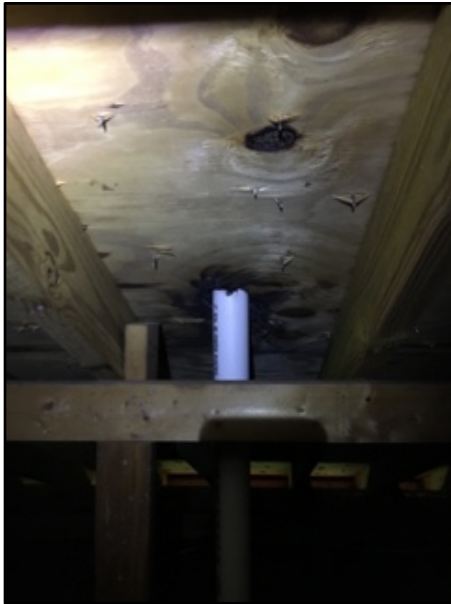
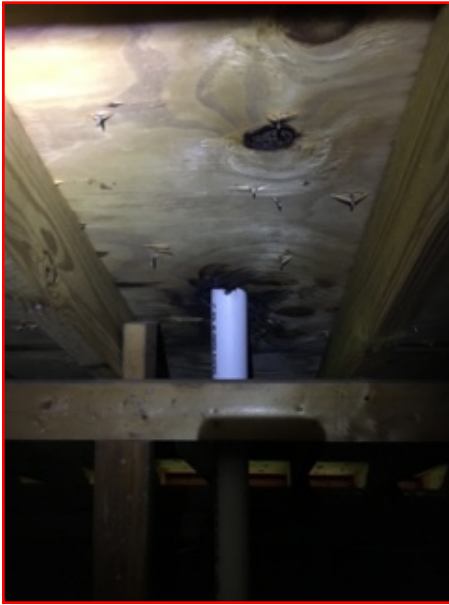
Figure 18-1

Where vent tubes penetrate roof in attic. Evidence of water intrusion. Further evaluation and repair by a qualified roofer recommended. Wood decking does not appear rotted at this time.

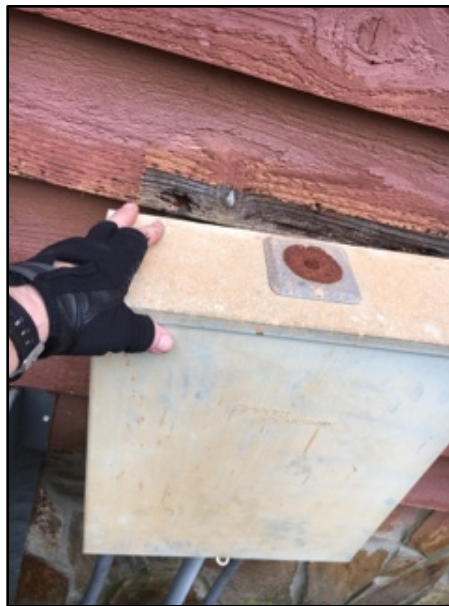
Electrical disconnect at HVAC system outside has come loose from wall.
Recommend repair.

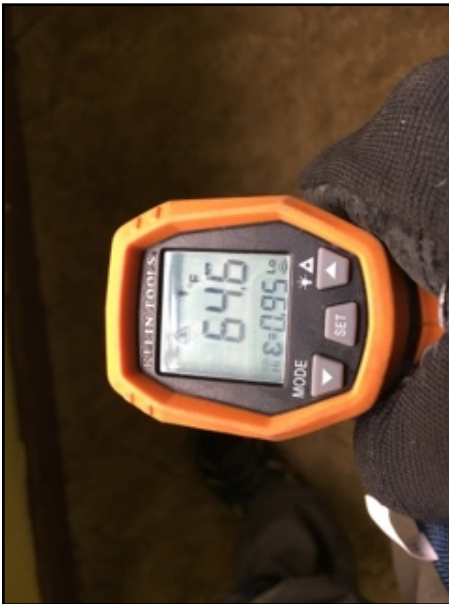
Figure 23-1

Comment 23:
Air temp good.

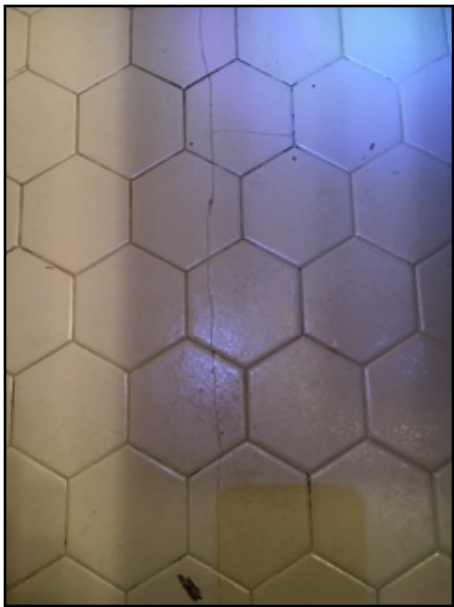
Figure 28-1

Comment 28:
Tile cracked.

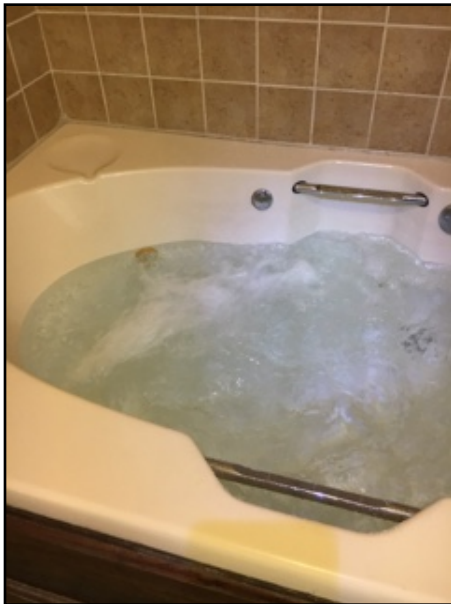
Figure 30-1

Comment 30:
Recirculating tub working.

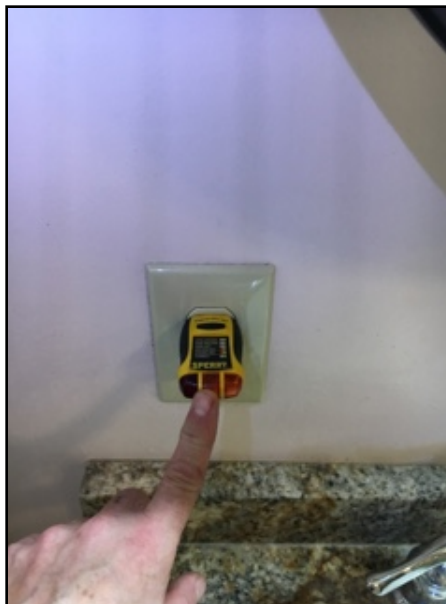
None of the outlets in bathroom working. Further evaluation by a qualified electrician recommended

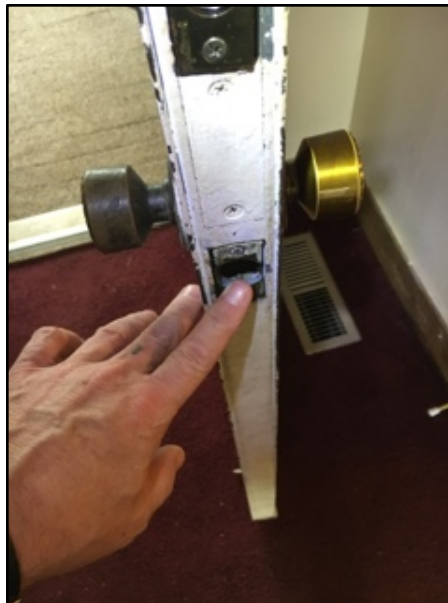
Rear door needs door knob replacement. Marginal.
