Integrity Pro Inspections, LLC

Home Inspection Report

**Any Home America
Albany, GA 31705**

Inspected on Sat, Dec 29 2018 at 9:30 AM

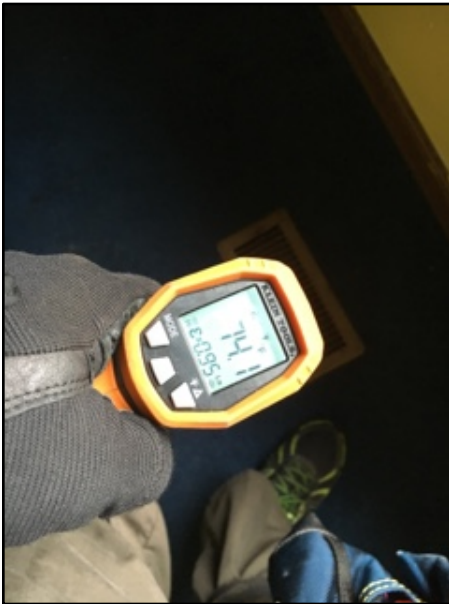
Figure 20-1

Comment 20:
Heating system temp good.

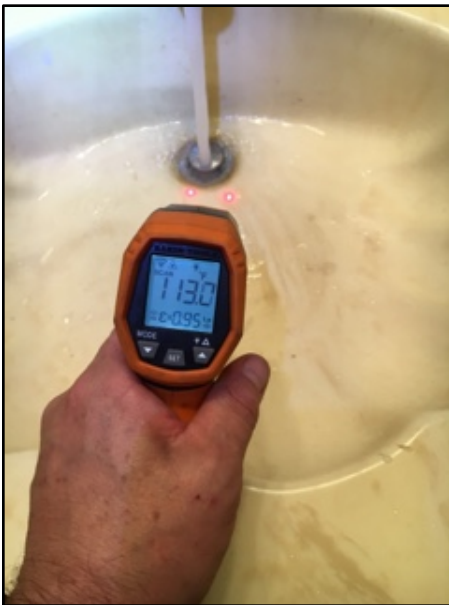
Figure 24-1

Comment 24:
Hot water temp good.

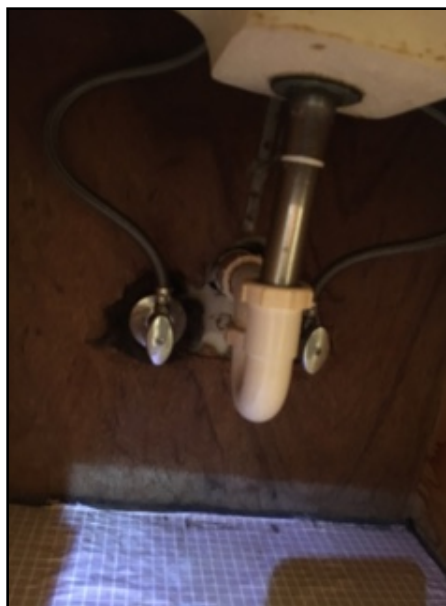
No leaks were observed at time of inspection.

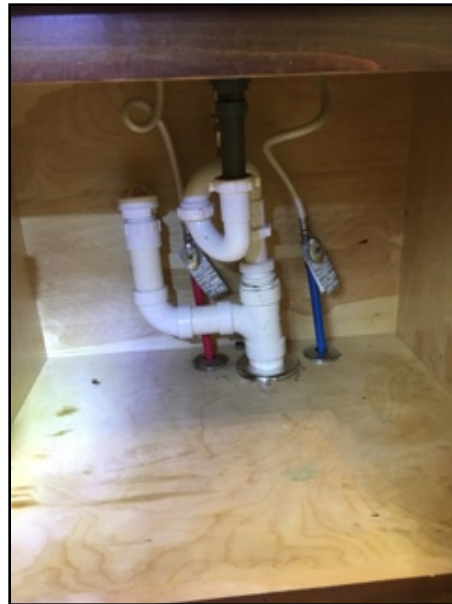
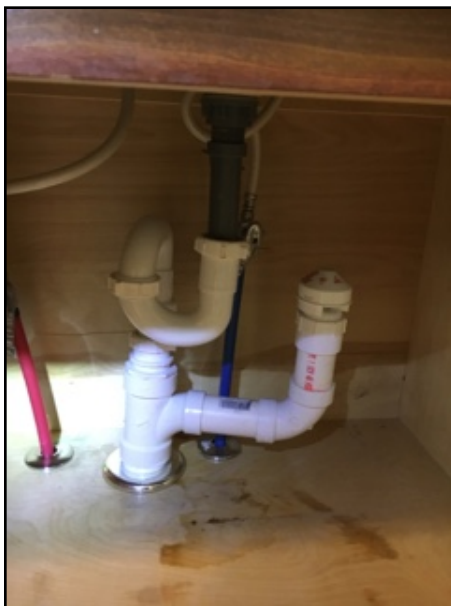
Comment 31:
No leaks were observed at time of inspection.
